CLUTCH LIFTER ROD PROBLEM

www.millarengines.com

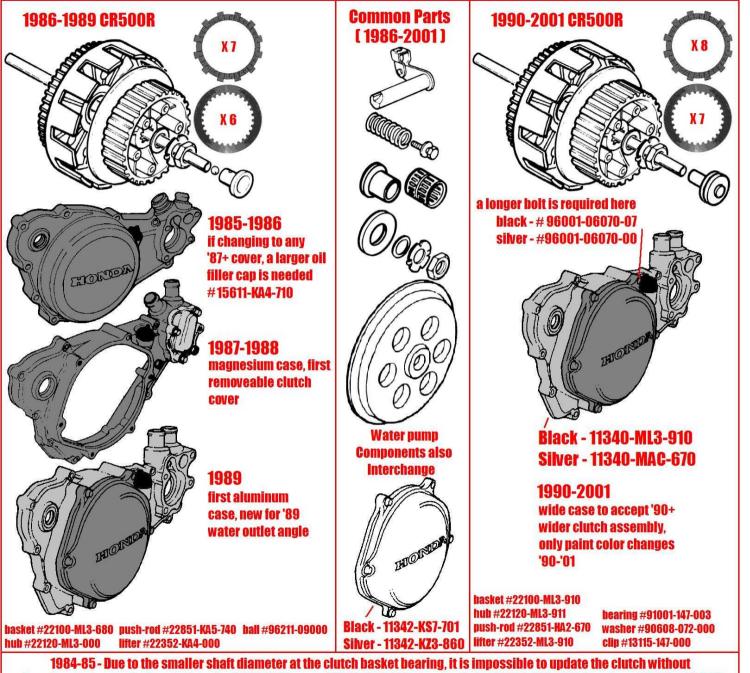
1984-85 - Due to the smaller shaft diameter at the clutch basket bearing, it is impossible to update the clutch without changing the transmission shaft to the 1986-2001 part #23210-ML3-000, bearing hub #22106-ML3-000, bearing #91021-ML3-003, washer #90457-ML3-000, and the basket, clutch hub combination that matches the case beeing used.

[Case dimensions limit updating a 1984 clutch to the 1986-1989 width basket] www.millarengines.com
