CLUTCH LIFTER ROD PROBLEM

www.millarengines.com

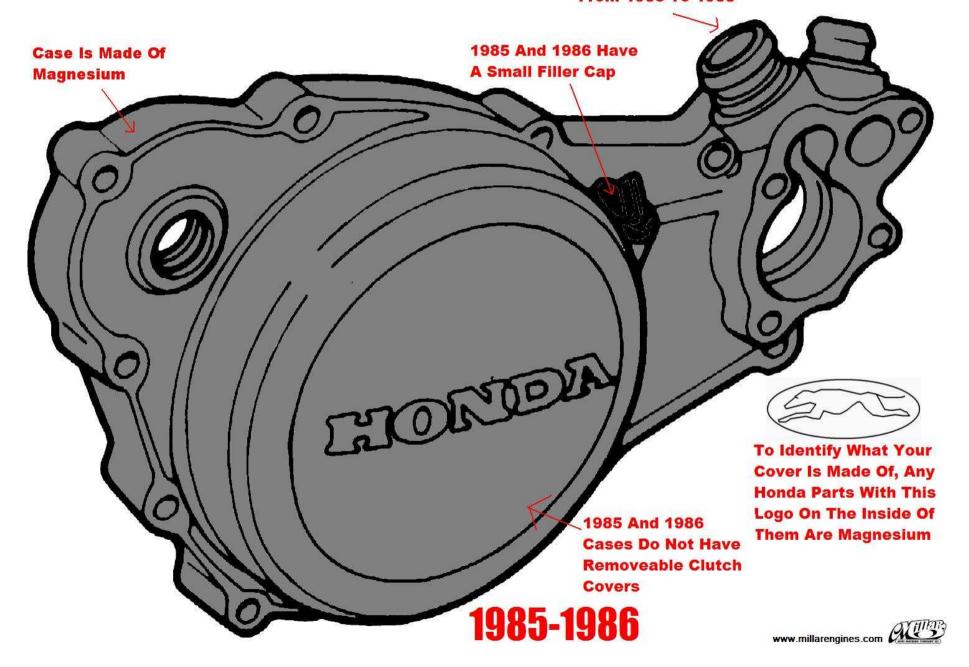
Water Outlets Are Angled Like This From 1985 To 1988
